Troubled Bridges

Over Clean Water

A Study of Neglected Railroad Bridges of Grays Harbor

A study of the rail bridges on the PSAP short-line from Centralia to Hoquiam.

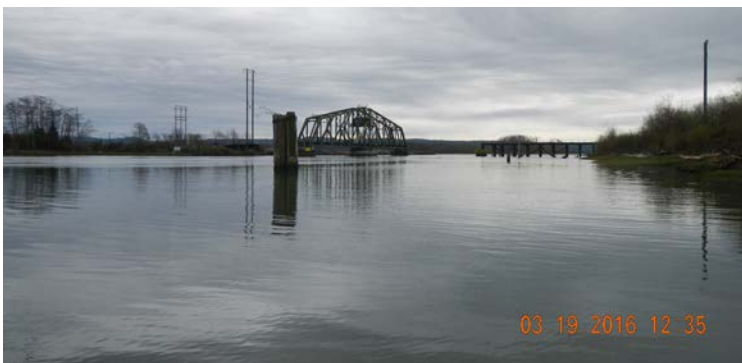
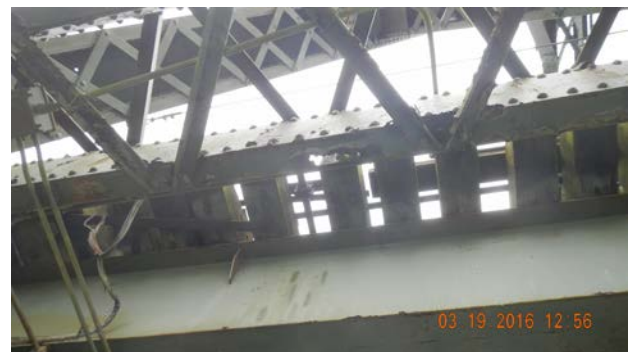
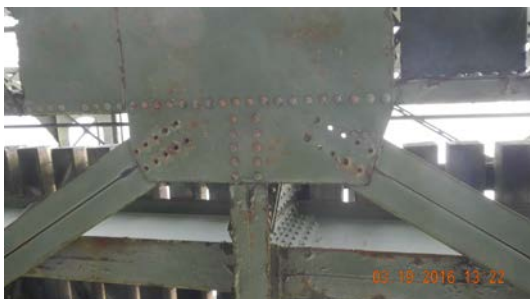
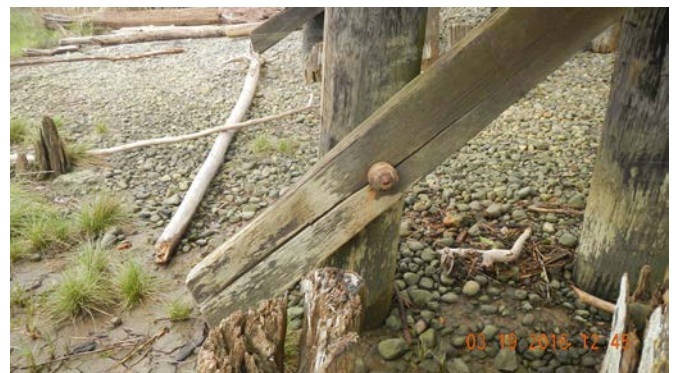
1. Hoquiam River Swing Bridge

Cracks in the foundation were observed as well as disconnected and rotten crossbeams. Evidence of eroded steel beams, cracked cross beams and missing cross beam bolts. Last marked inspection was 1992.

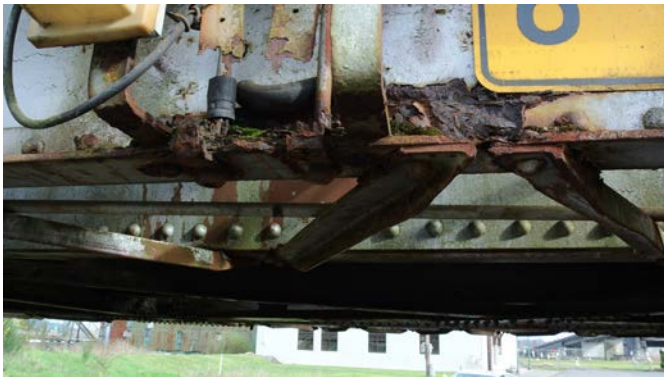
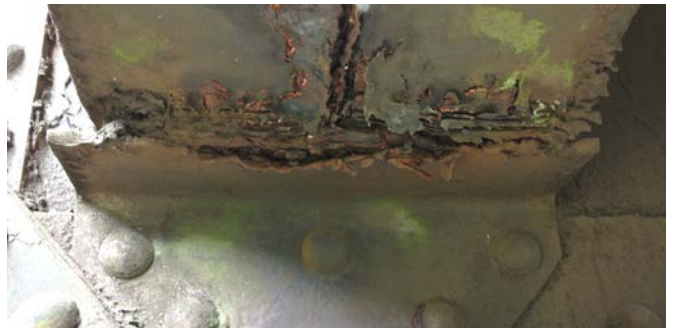
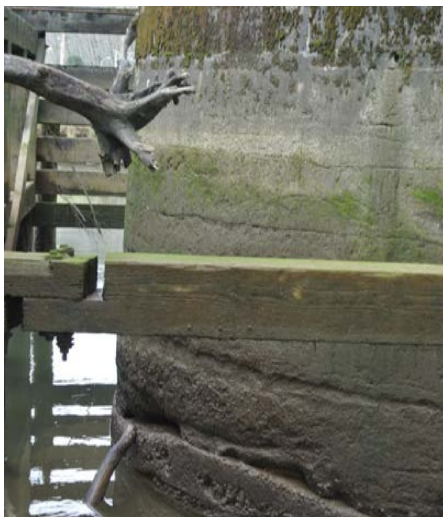
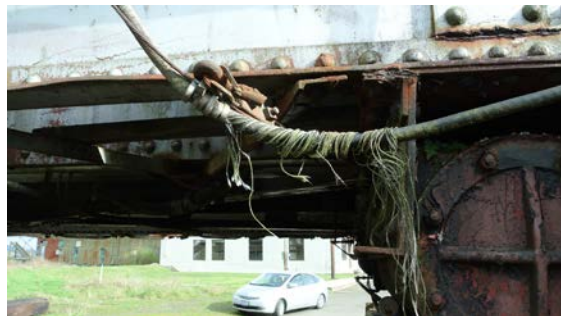
2. Wishkah River Bridge

Eroded and cracked cross beams were observed. In addition-
al there was unguarded wiring and many rust-eaten beams.

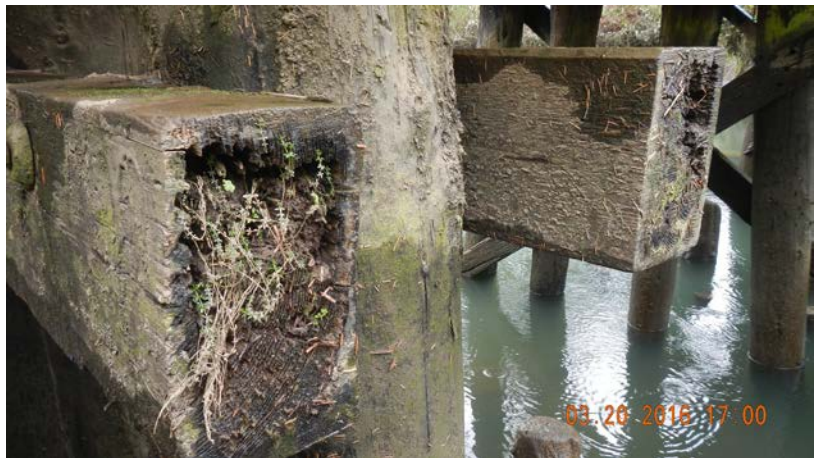
4. Unnamed crossing- over Chehalis River

Rotted, truncated and disconnected cross beams. Heavily rusted bolt and cracked beams,. Inspected 1990.

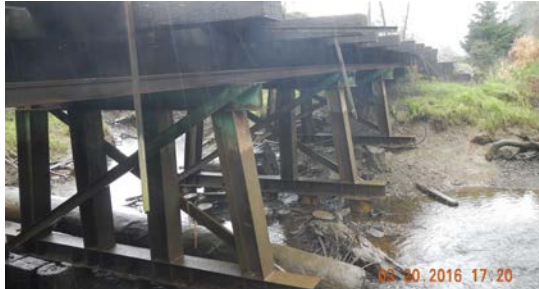
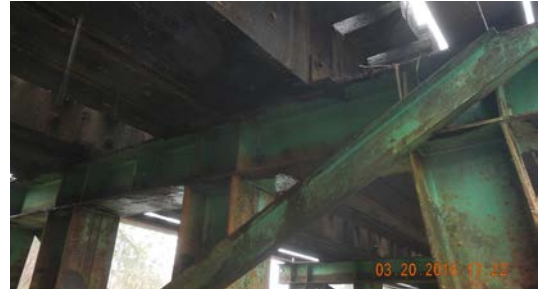
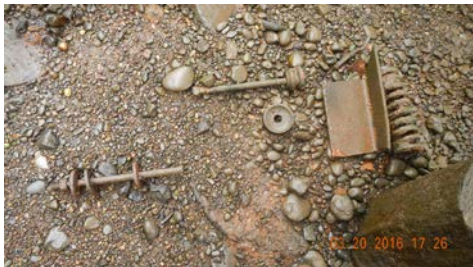
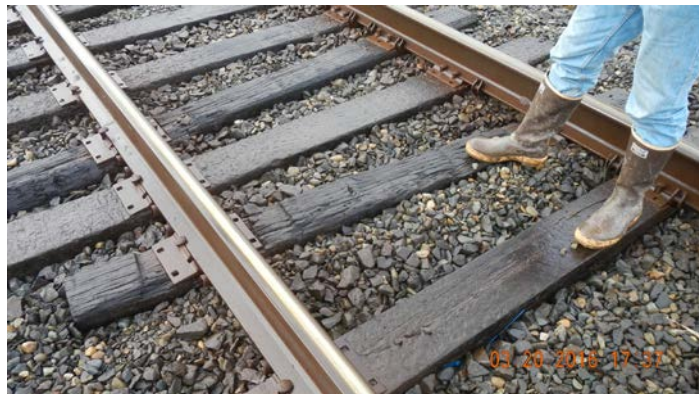
5. Unnamed crossing- Elliot Slough

Debris, loose and missing spikes. Shifted tie and one unsupported tie. Rusty steel.

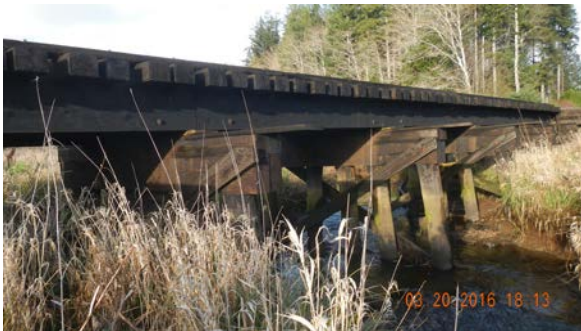
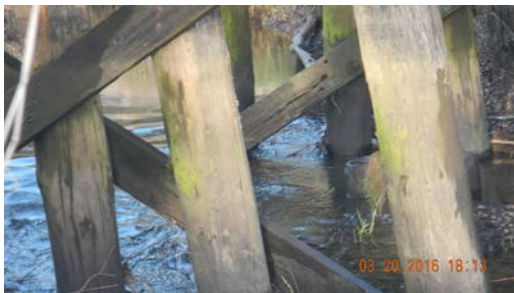
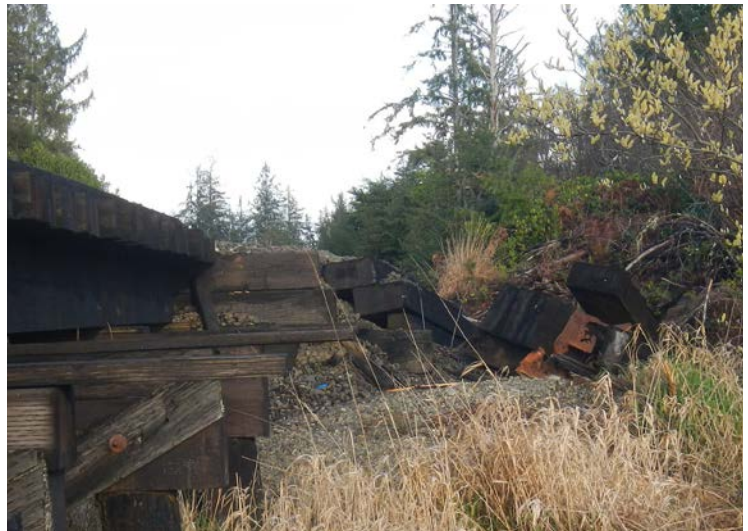
6. Unnamed crossing- Mox Chuck Slough

Cracked cross-beam, debris in-stream and at edge.

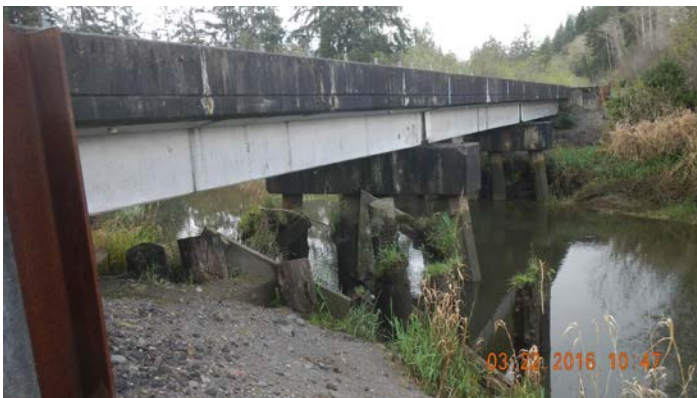
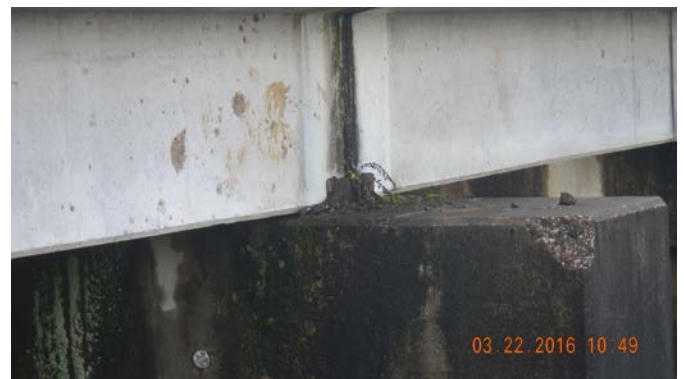
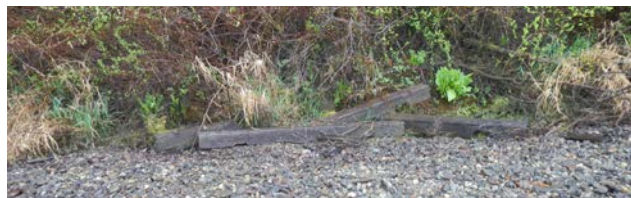
7. Unnamed crossing- Higgins Slough

All four lateral angle braces rusted, debris along channel bed and creek

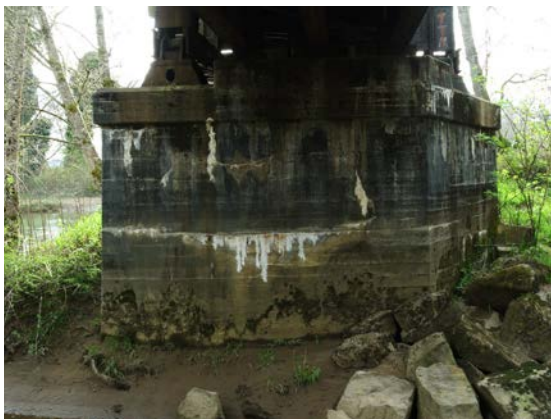
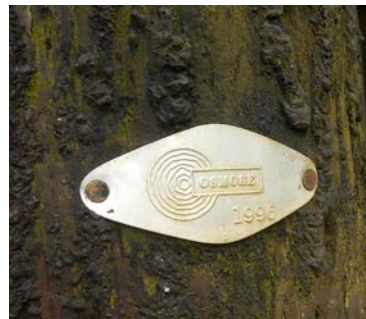
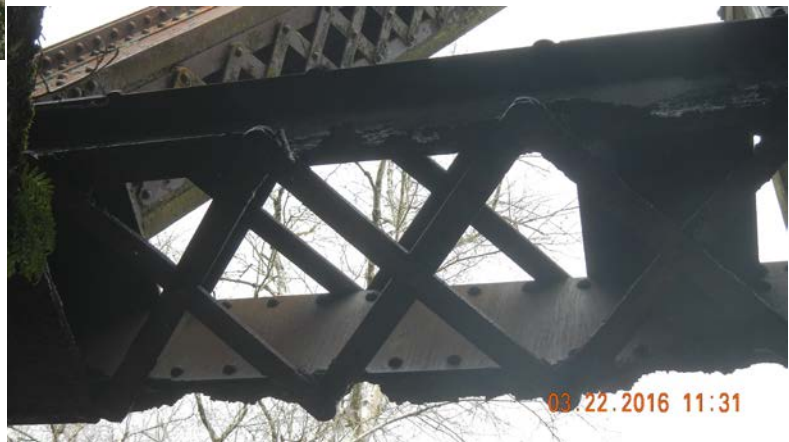
8. Wynooche River Rail Bridge

Foundation shows cracks and leaching. Extreme rust throughout. Rust-eaten beams and cross member. Debris at the side of the bed and leading to the water.

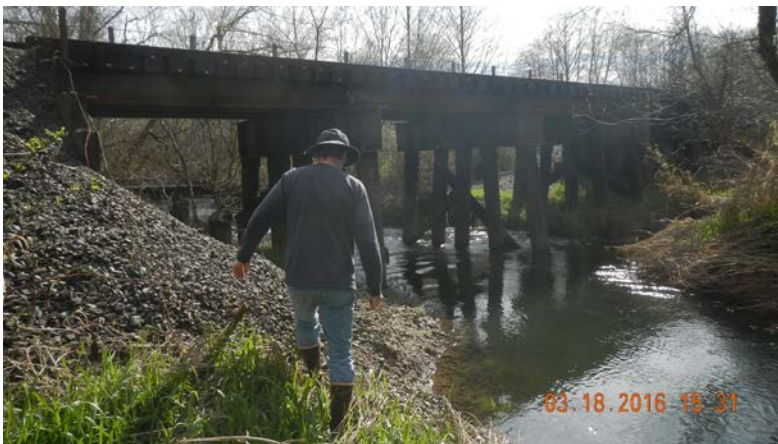
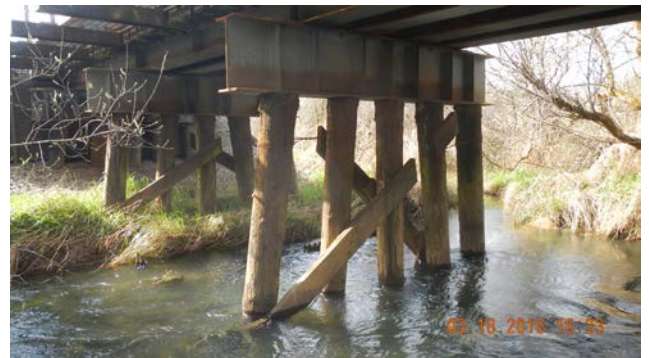
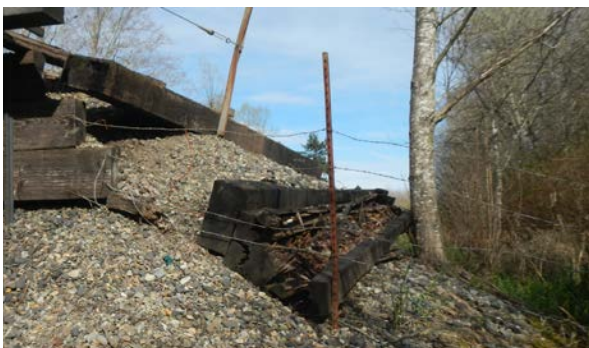
9. Unnamed crossing- Sylvia Creek

Cut crossbars, gravel in the creek. Debris on track side and rotted ties visible. Inspection date 1996.

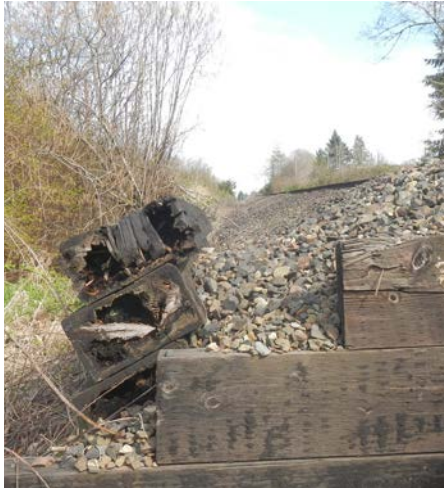
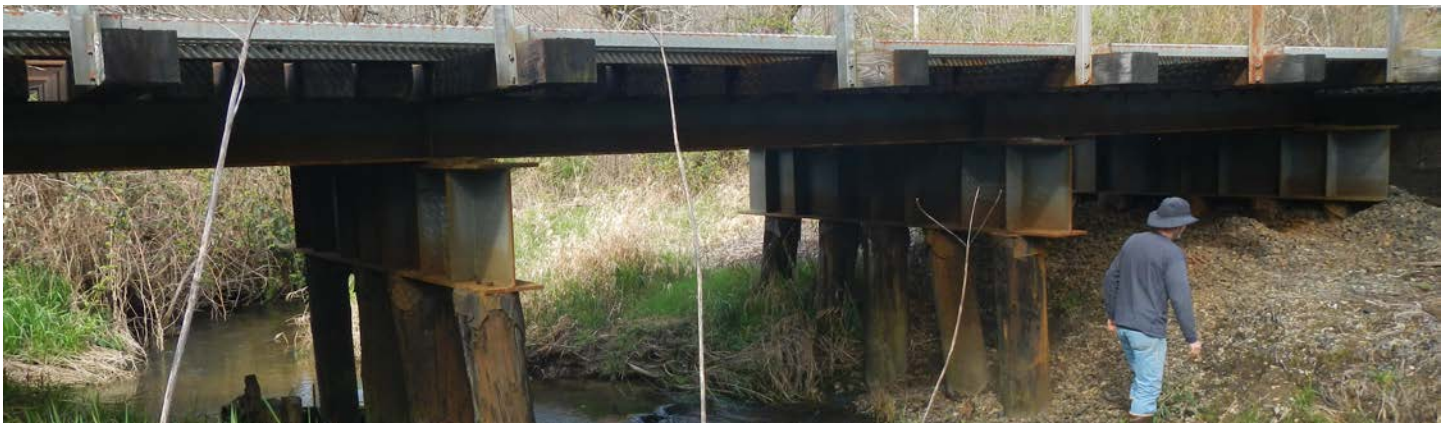
10. Unnamed crossing- Camp Creek

Gravel in the stream, old creosote timbers along the track and debris in the stream

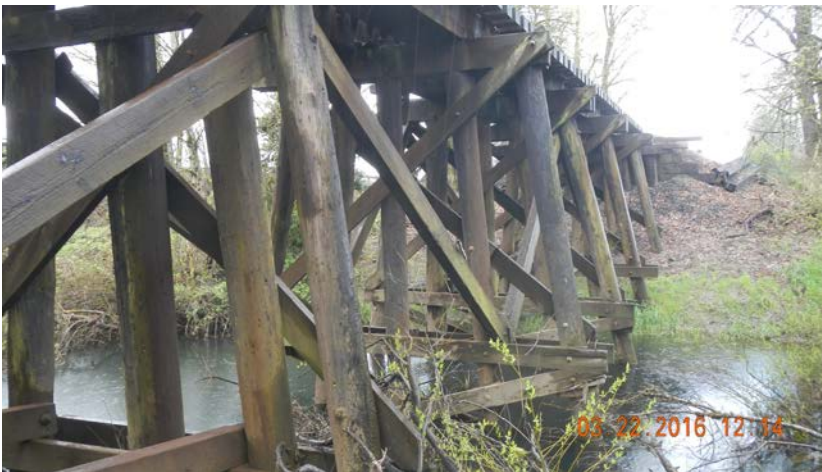
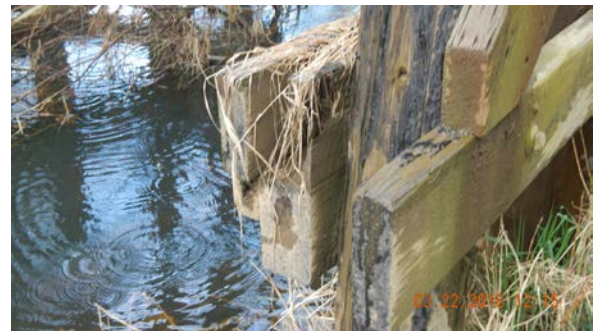
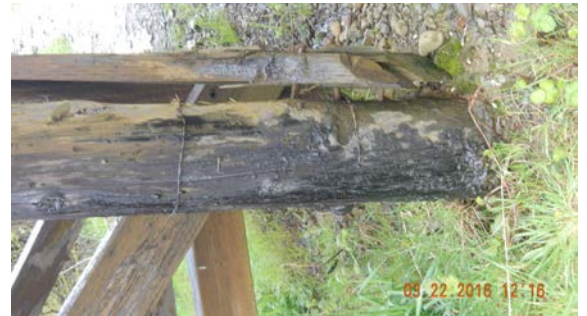
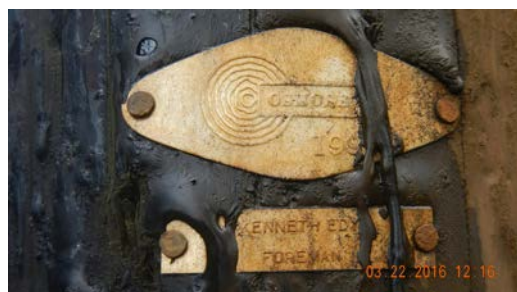
11. Unnamed crossing- unnamed creek

Cracked crossbeams, evidence of crossbeam end rot.
Partially disconnected cross-beam. Inspected 1993

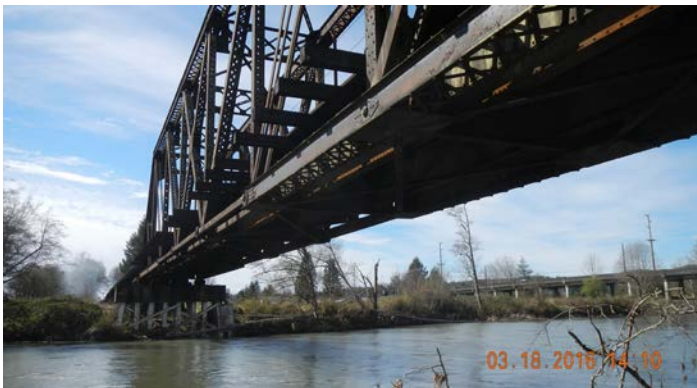
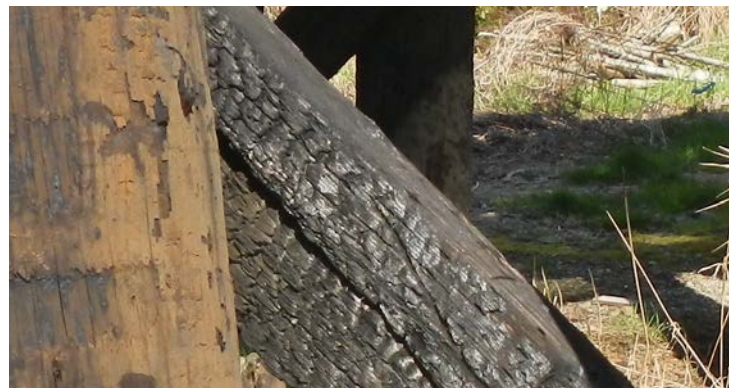
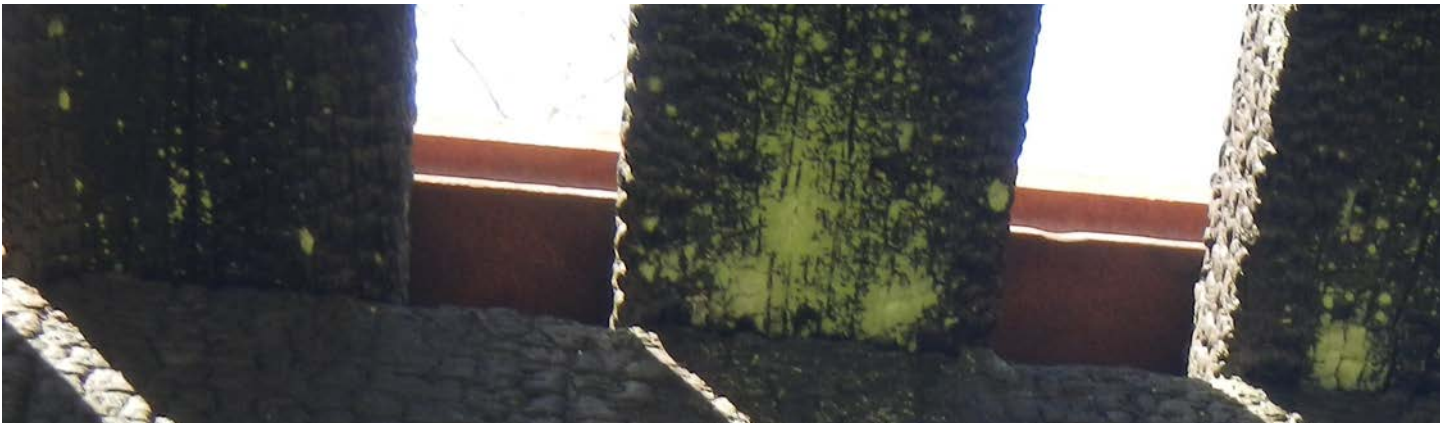
12. Satsop River Bridge

East approach has burnt and cracked timbers, supports and cross-beams. Last inspected 1992
